Manhole Inspection Summary

Manhole # S35MM_064MH

Location Address: **2003 GUILDFORD AVE**

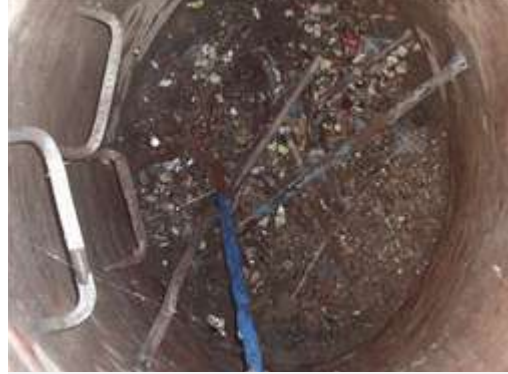
Top View

Corroded steps. Channel debris.

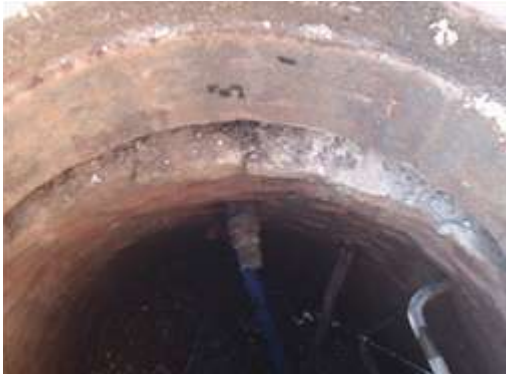
Defect

Frame leaks. Frame offset. Adjustment deterioration and infiltration.

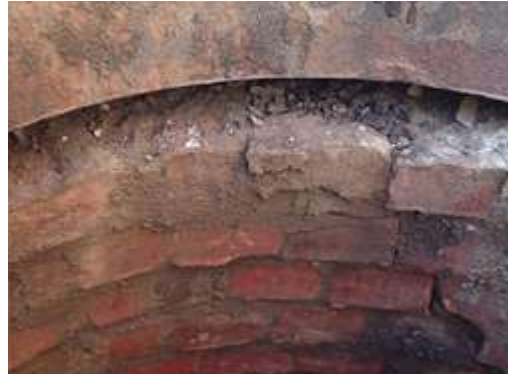
Defect

Frame leaks. Adjustment deterioration and infiltration.

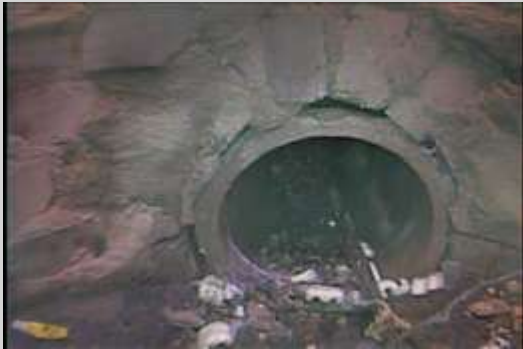
8 in. Circular Gravity Sewer
Pipe Out @ 12 O'Clock

Deposits: ☐ None ☒ **Mud** ☐ Sludge ☒ **Debris** ☐ Grease

Silt Depth: **0.5** (in.) Deposits Extent: **Light**

Infiltration: **None** Pipe Seal Cond: **Broken**
